QUALITY ESPRESSO

## TECHNICAL NOTE

21.051-NT

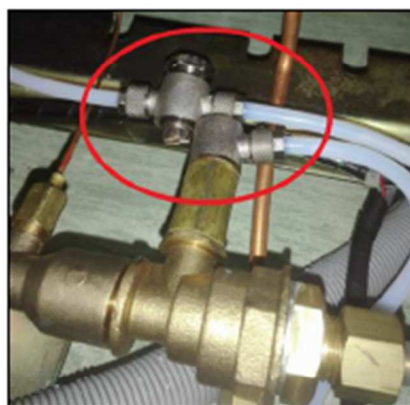
**PROBLEM:** Sometimes the 1 or 2 way swivel screw breaks during installation.

**SOLUTION:** The rotary screw mounted on the collector assembly of the OTTIMA (1 and 2 groups) and LA NERA (1 group) coffee machines has been updated.

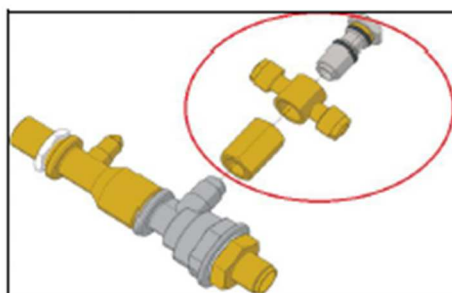
For 1 group machines, the affected part is the screw with code 08504500, and it is replaced by the new screw with code 08509900. This screw is part of sub-assembly 08492420.

For machines with 1 group, the sub-assembly must be ordered: 08492420.

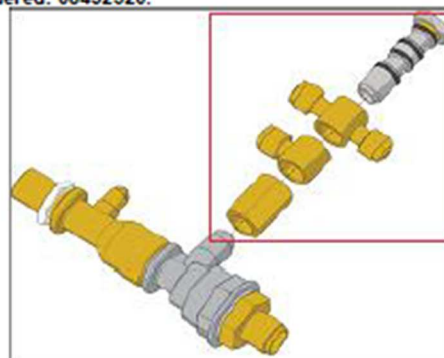
For machines with 2 groups, the affected part is the screw with code 08504510, it is replaced by the new screw with code 08509910. This screw is part of sub-assembly 08492520.

For 2 group machines, the set must be ordered: 08492520.
